DMIC Technical Note
February 1, 1966

- ⑥ THE STRESS-CORROSION AND ACCELERATED
CRACK-PROPAGATION BEHAVIOR OF TITANIUM
AND TITANIUM ALLOYS .

DEFENSE METALS INFORMATION CENTER
BATTELLE MEMORIAL INSTITUTE
COLUMBUS, OHIO 43201

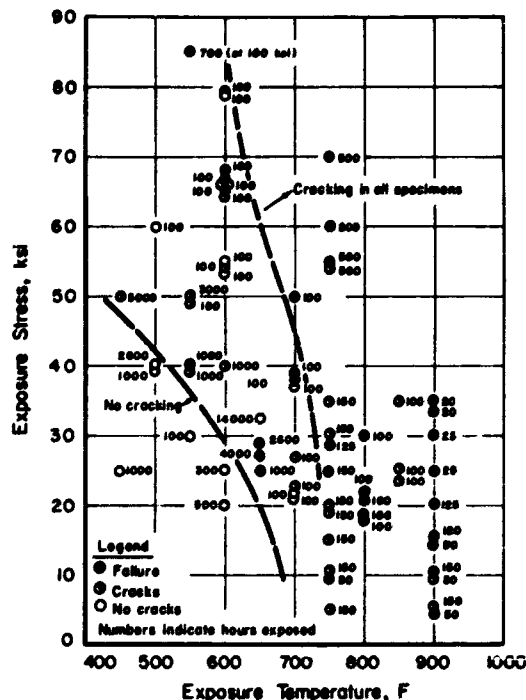
FIGURE 1. EFFECT OF EXPOSURE VARIABLES ON THE OCCURRENCE OF VISIBLE SALT STRESS-CORROSION IN Ti-8Al-1Mo-1V(7)

These general effects of temperature, stress, and time are illustrated for the Ti-8Al-1Mo-1V alloy in Figure 1 which summarizes data reported prior to April, 1965.(7) Some inconsistencies are apparent in this figure and probably arise from differences in heat treatment and/or the test conditions that were used by the various sources. More recent information indicates, for example, that stress-corrosion cracking, per se, of titanium alloys "does not occur at 500 F, at least within 8000 hours", although it does occur at 525 F "under high stresses and long times".(5) Figure 2 shows some 1000 hour exposure data for several alloys which agree with this premise. On the other hand, other investigators have shown that some of the

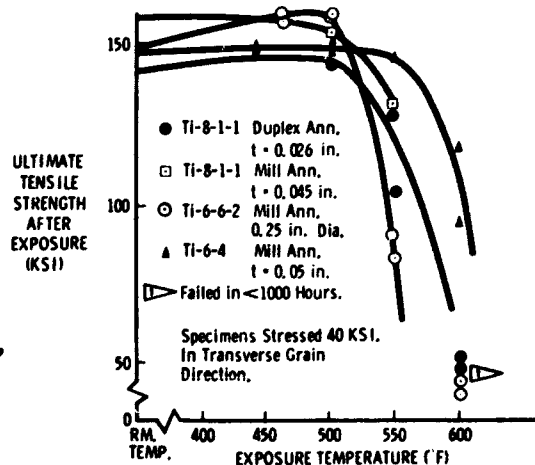
FIGURE 2. RESIDUAL STRENGTH OF TITANIUM ALLOYS AFTER EXPOSURE TO SODIUM CHLORIDE FOR 1000 HOURS(8)

Cyclic exposure to hot salt is apparently less severe even when total time at temperature is the same. Two heats of Ti-8Al-1Mo-1V (duplex annealed) were exposed to alternate dip in 3-1/2 percent NaCl water for 10 minutes and 550 F for 2-1/2 hours at stresses of 50 to 90 percent of yield strength.⁽⁸⁾ After 2000 hours (667 cycles) no effects of stress-corrosion cracking were observed, and almost no degradation of physical properties was detected. This can be compared with the 1000-hour degradation as shown in Figure 2.

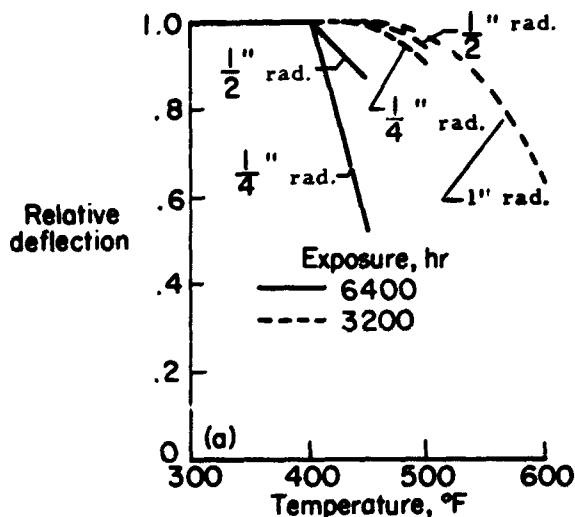
FIGURE 3. STRESS-TEMPERATURE THRESHOLDS FOR DUPLEX ANNEALED Ti-8Al-1Mo-1V RESIDUAL STRESS SPECIMENS⁽⁹⁾

Samples previously bent through radii shown, then salt coated and exposed at temperatures from 400 F to 600 F for times indicated, and bent to failure at room temperature.

more susceptible alloys display susceptibility at temperatures below 500 F and times of less than 8000 hours. Specifically, Figure 3 from a NASA study(9) shows the changes in room-temperature ductility that were observed on residual stress specimens of duplex annealed Ti-8Al-1Mo-1V after

exposures of 3200 and 6400 hours at temperatures down through 400 F. These results indicate that, for exposures of 6400 hours, some damage has occurred on the material exposed at temperatures slightly above 400 F.

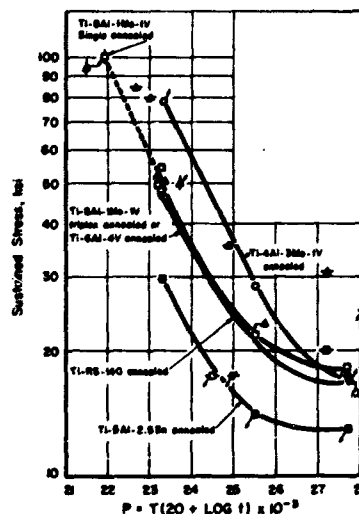
FIGURE 4. APPLICATION OF LARSEN-MILLER PARAMETER FOR PREDICTING STRESS-CORROSION CRACKING BY HOT SALT OF ANNEALED TITANIUM ALLOYS^(10,12)

The combined effects of time, temperature, and stress for several titanium alloys are shown in Figure 4,^(10,12) which represents data from many sources. These data suggest the stress-

corrosion cracking thresholds for the various alloys. This plot employs the empirical Larson-Miller parameter, originally used for generalizing creep data in steel.⁽¹³⁾ Excellent agreement is indicated for the data. From this plot, the estimated threshold stress for hot-salt cracking at 550 F and 30,000 hours is 45,000 psi for Ti-4Al-3Mo-1V (annealed), 30,000 psi for Ti-8Al-1Mo-1V (triplex annealed) and Ti-6Al-4V (annealed), 28,000 psi for Ti-5Al-2.75Cr-1.25Fe (annealed) and 18,000 psi for Ti-5Al-2.5Sn (annealed).

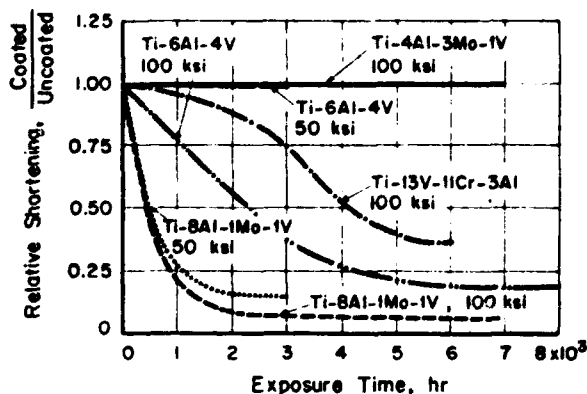
FIGURE 5. EFFECT OF TIME AND STRESS ON THE 550 F SALT-STRESS-CORROSION DEGRADATION OF PROPERTIES OF SELECTED TITANIUM ALLOYS⁽¹⁴⁾

The ductility of titanium alloys is also reduced after long-time exposure to hot salt. This has been shown, for example, in a NASA study⁽¹⁴⁾ where mill-annealed Ti-8Al-1Mo-1V sheet and various other titanium alloy sheets were exposed at 550 F for times up to 7000 hr at 50 and 100-ksi stress levels. These were salt coated, restrained bend specimens which after exposure were bent to smaller radii until failure occurred (see reference for test details). For convenience of measurement, chord length was measured at the point of specimen failure which was then compared with chord length (i.e., as a measure of deformation) of salt-free exposed samples. A summary of the results obtained in this study is given in Figure 5. The experiments indicate the relatively high susceptibility of mill-annealed Ti-8Al-1Mo-1V alloy under these conditions.

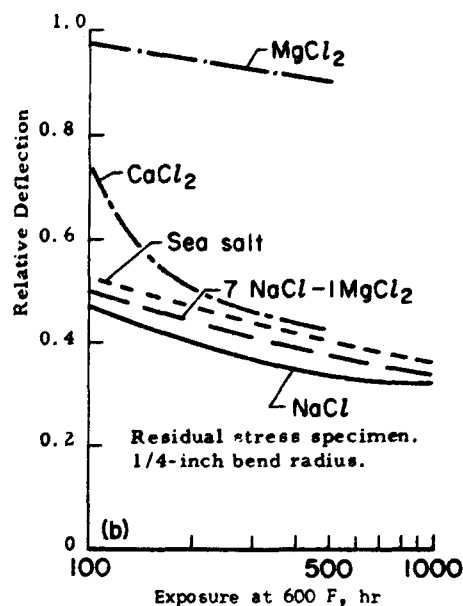
FIGURE 6. EFFECT OF TYPE OF SALT ON STRESS CORROSION OF DUPLEX ANNEALED Ti-8Al-1Mo-1V ALLOY SHEET AT 600 F⁽⁹⁾

The relative cracking effect of several salts on the Ti-8Al-1Mo-1V is shown in Figure 6.⁽⁹⁾ This shows the loss of ductility after exposure at 600 F of samples that were residually stressed (by bending over a 1/4-inch radius) to 66 ksi, then bent to failure after exposure. Sodium chloride had the most severe effect followed by 7NaCl-1MgCl₂ and sea salt, in that order. $MgCl_2$, by itself, caused only a slight loss of ductility. These results have been confirmed by others.^(8,17)

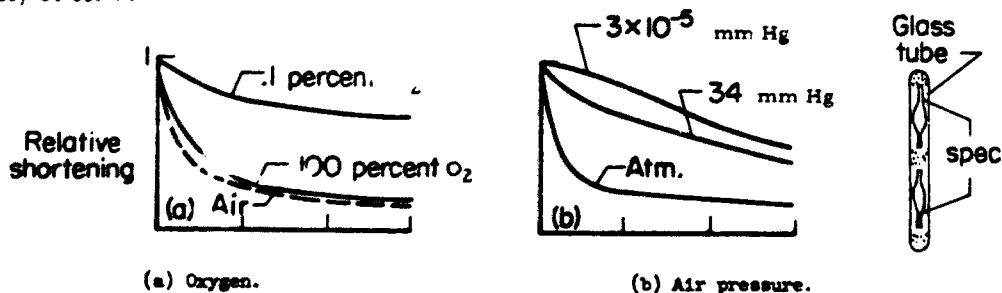
FIGURE 8. EFFECT OF OXYGEN AND AIR PRESSURE ON SALT STRESS CORROSION OF DUPLEX ANNEALED Ti-8Al-1Mo-1V ALLOY SHEET AT 550 F.⁽⁹⁾ (See also Figure 5)

The loss of ductility of stressed titanium specimens exposed to hot salt is lessened as the oxygen content or air pressure is reduced.^(9,18) This is shown in Figure 8. At an air pressure equivalent to 7000 feet altitude, 34 mm Hg, a decrease in ductility is indicated over that at atmospheric pressure for the Ti-8Al-1Mo-1V alloy at 550 F.

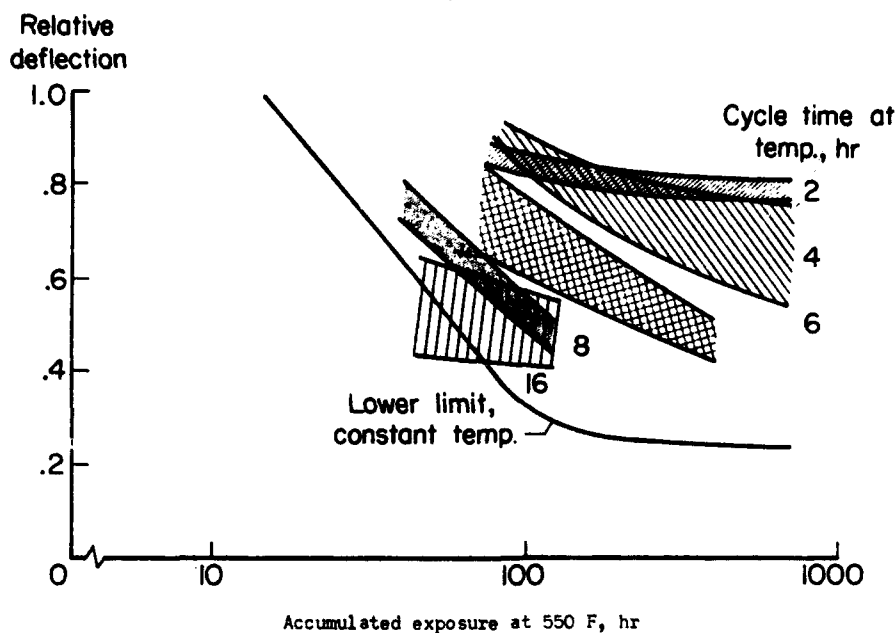
FIGURE 9. EFFECT OF 2-, 4-, 6-, 8-, and 16-HOUR THERMAL CYCLES ON SALT-STRESS CORROSION OF DUPLEX-ANNEALED Ti-8Al-1Mo-1V ALLOY SHEET AT 550 F

(Tests with residual stress specimens initially bent to 1/8-inch radius for a calculated residual stress of 70 ksi.)⁽⁹⁾

In other studies, the cycle time and temperature were varied.⁽⁹⁾ A salt dip was employed only prior to the exposure. Figure 9 shows the results of this work. Note that the curves indicate time at temperature. Only slight degradation of the ductility of the Ti-8Al-1Mo-1V alloy occurs at 550 F when the cycle time is 2 hours at temperature. The degradation increases as the time at temperature increases. However, even with 16-hour cycle time, the amount of degradation did not appear to be as severe as continuous exposure.

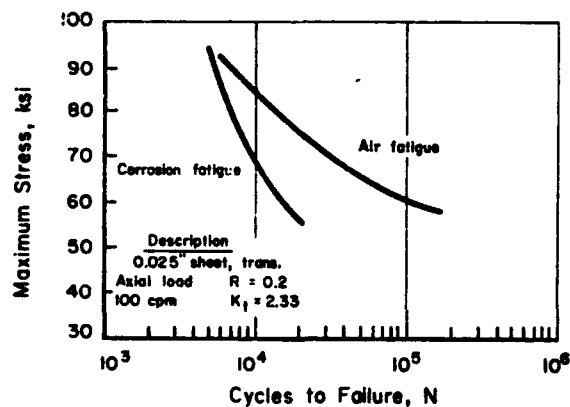
FIGURE 10. CORROSION FATIGUE AND AIR-FATIGUE S-N CURVES FOR Ti-8Al-1Mo-1V TRIPLEX ANNEALED⁽¹⁰⁾

Tested at 800 F with or without salt coating.

Fatigue does not appear to have much effect on the hot-salt susceptibility of most titanium alloys at elevated temperature.⁽¹⁰⁾ Ti-4Al-3Mo-1V (annealed or aged), Ti-5Al-2.5Sn (annealed), Ti-6Al-4V (annealed or aged), Ti-5Al-2.5Cr-1.25Fe (annealed), and Ti-8Al-1Mo-1V (triplex annealed) were not susceptible to salt-corrosion fatigue at 600 F using synthetic sea salt. The Ti-4Al-3Mo-1V (annealed), Ti-6Al-4V (annealed or aged), and Ti-5Al-2.75Cr-1.25Fe (annealed) were not affected by salt when tested at 800 F. Only Ti-8Al-1Mo-1V showed reduced fatigue life, but only when exposed to synthetic sea salt at 800 F. At 60,000 psi, the cycles to failure were reduced from 10^5 to about 10^4 cycles, at 100 cpm. These results are shown in Figures 10 and 11.

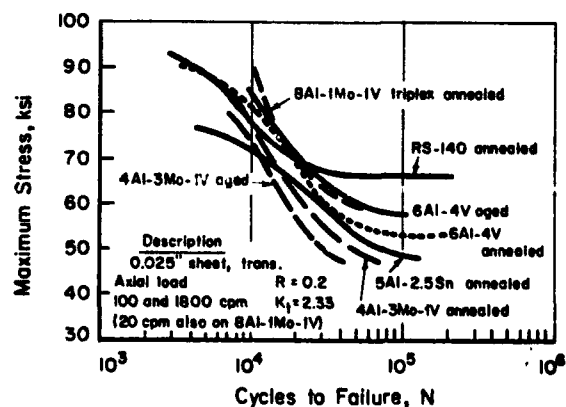
FIGURE 11. CORROSION FATIGUE OR AIR-FATIGUE (SAME) S-N CURVES FOR TITANIUM ALLOYS⁽¹⁶⁾

Tested at 600 F, with and without salt coating.

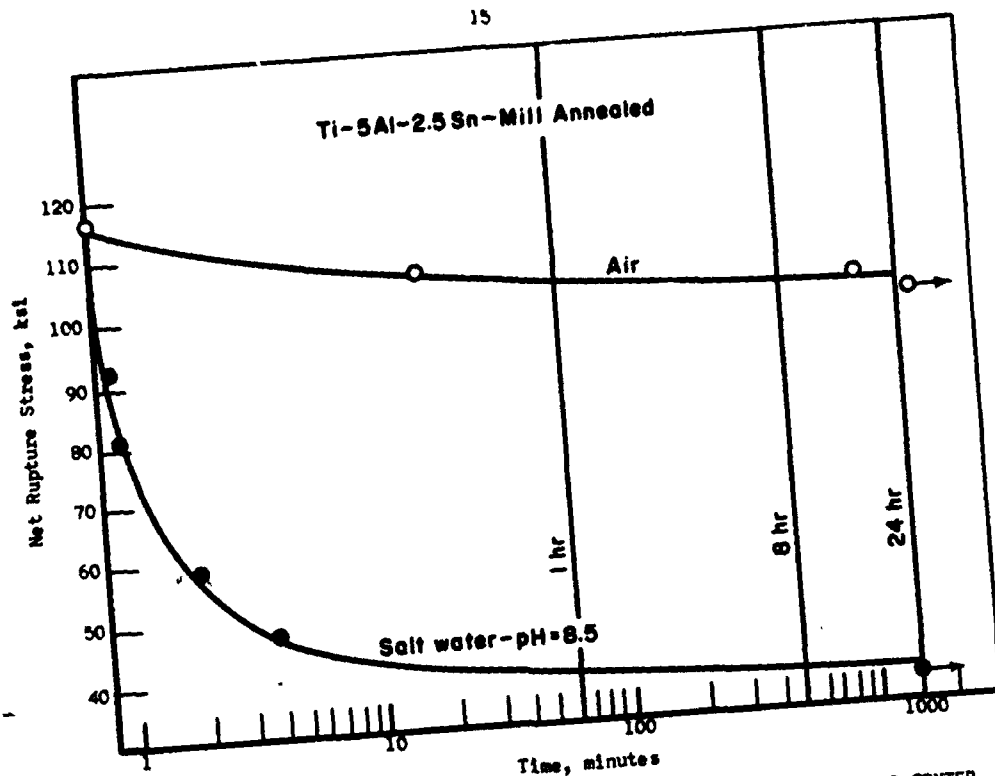
FIGURE 12. STRESS-RUPTURE CURVES IN AIR AND 3.5 PERCENT SALT WATER FOR CENTER FATIGUE-CRACKED SPECIMENS(34)

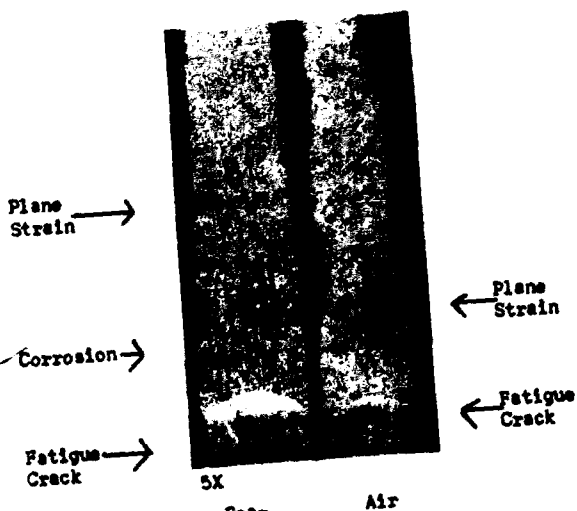
FIGURE 13. APPEARANCE OF FAILED NOTCH-TEST SPECIMENS, MATERIAL USED WAS 0.125-IN-THICK SHEET OF Ti-5Al-2.5Sn ALLOY(35)
The photograph was reduced approximately 20 percent in printing.

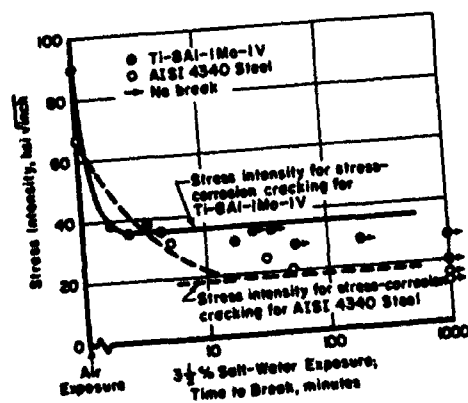
FIGURE 14. TEST RESULTS FOR Ti-8Al-1Mo-1V AND AISI 4340 STEEL IN AIR AND AQUEOUS 3.5% NaCl ENVIRONMENT(3)
Fatigue precracked cantilever-beam specimens.

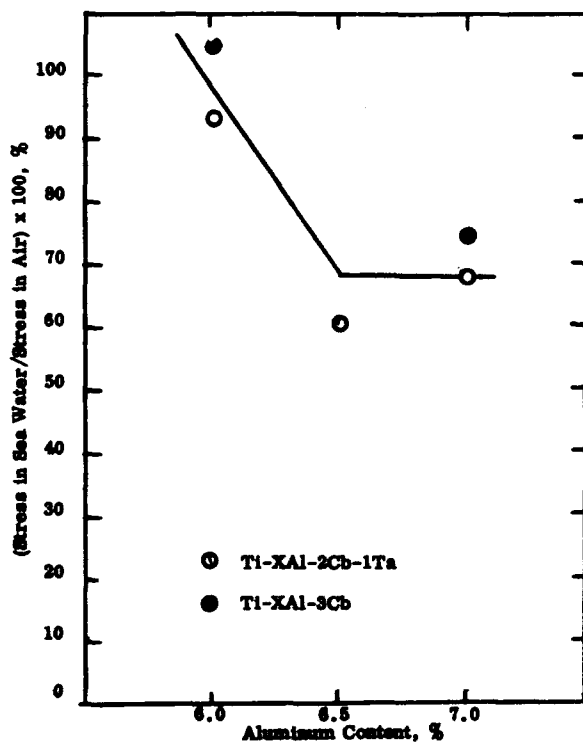
FIGURE 15. EFFECT OF ALUMINUM CONTENT ON THE SEAWATER TO AIR FAILURE STRESS RATIO OF BETA-ANNEALED PLATE⁽³⁹⁾

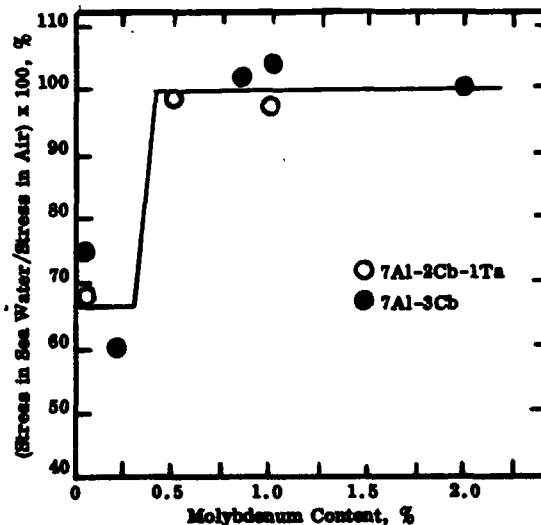
FIGURE 16. EFFECT OF MOLYBDENUM CONTENT ON THE SEAWATER TO AIR FAILURE STRESS RATIO OF BETA-ANNEALED PLATE⁽³⁹⁾

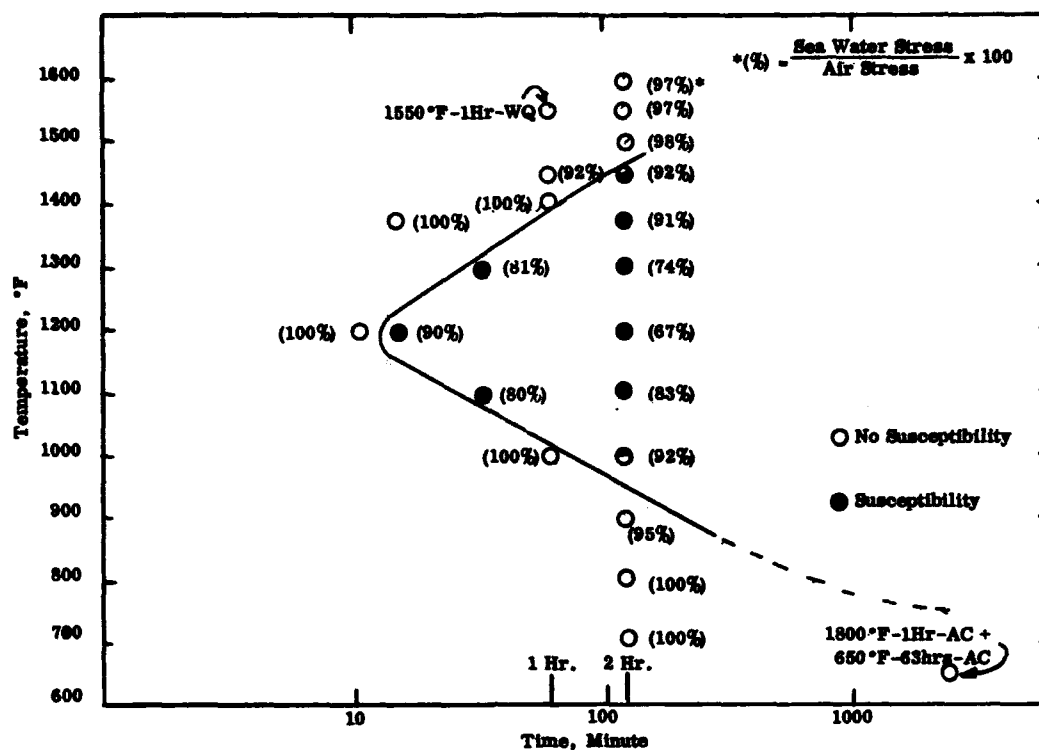
FIGURE 17. EFFECT OF EXPOSURE TEMPERATURE AND TIME ON THE STRESS-CORROSION CRACKING OF Ti-8Al-1Mo-1V PLATE IN ROOM TEMPERATURE SYNTHETIC SEAWATER⁽³⁹⁾

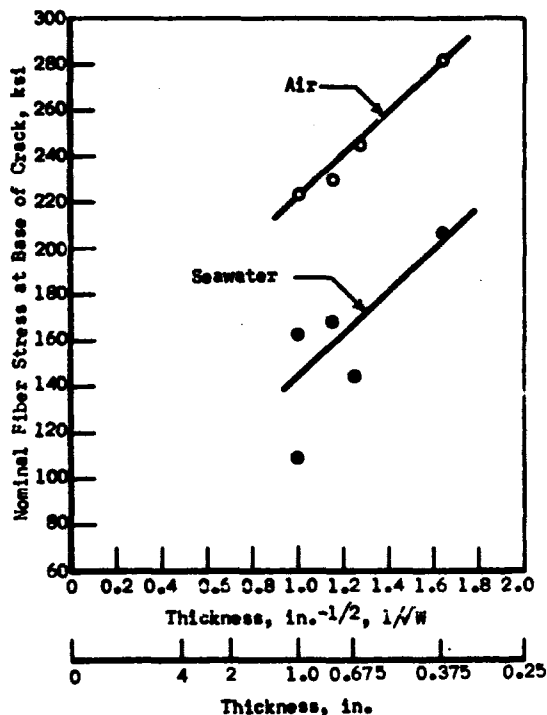
FIGURE 18. EFFECT OF PLATE THICKNESS AND TESTING MEDIA ON THE NOMINAL FIBER STRESS AT FAILURE IN PRE-CRACKED BETA-ANNEALED Ti-7Al-2Cu-1% Ti ALLOY, THREE-POINT BEND SPECIMENS(35)

The degree of susceptibility of an alloy which is sensitive to salt-water cracking is affected by the specimen thickness. Most reproducible results are obtained for plate of 1/2- to 1-inch thickness. In thin sections, the specimen tends to rupture in full shear, masking the effects of corrosion. This can be shown by Figure 18.(35)

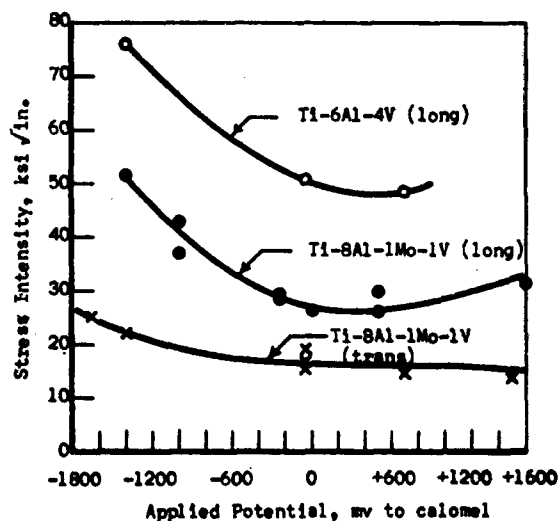
FIGURE 19. THE EFFECT OF APPLIED POTENTIAL ON THE STRESS INTENSITY FACTOR TO CAUSE FAILURE IN 3-1/2 PERCENT SALT WATER⁽⁴¹⁾

Applied Potential, mv to calomel

The available evidence strongly suggests that the mechanism is electrochemical in nature. For example, studies have shown that cathodic protection can prevent crack propagation and can arrest propagation when applied to a moving crack.⁽⁴¹⁾ The electrochemical behavior of crack propagation is shown in Figure 19. The effect of applied potential on the susceptibility of Ti-8Al-1Mo-1V and Ti-6Al-4V to salt-water cracking can be seen. Note that the application
